⊚2002, 2008, 2014, 2015, 2018 Horizon Global Corp. SHEET 1 OF 2 N75138 N44735 11-26-18 HITCH NO. VEHICLE INSTALLATION INSTRUCTIONS PONTIAC AZTEK - ALL MODELS 75138 BUICK RENDEZVOUS - ALL MODELS 44735 EQUIPMENT REQUIRED: PHILLIPS SCREWDRIVER, PLIERS 78257 UHAUL WIRING ACCESS LOCATION:SUV1, SUV2 DRILL BITS: NONE HITCH REQUIRES 5/8" PIN AND CLIPIF STABILIZING PIN IS NOT INSTALLED. WRENCHES: (TIGHTEN ALL FASTENERS WITH TORQUE WRENCH)15mm, 3/4, 17mm DO NOT EXCEED LOWER OF TOWING VEHICLE MFR'S RATINGS OR MAX GROSS MAX HITCH TYPE TRLR WT(LB) WEIGHT CARRYING 3500 FASCIA DO NOT USE WITH WEIGHT-DISTRIBUTING (SPRING BAR TYPE) HITCH. 00 n HITCH SHOWN IN PROPER POSITION BULKHEAD VEHICLE FRAME O and BOLT, M10 X 1.50 X 35mm CL10.9 CONICAL TOOTHED WASHER 3/8 TYPICAL (4) PLACES Om OPTIONAL LOCKING STABILIZING PIN J-PIN a 000 FIGURE 1 1. REMOVE REAR FASCIA FROM VEHICLE AS FOLLOWS: (Order Separately) AZTEK a. REMOVE (5) PUSH-IN RETAINING CLIPS FROM UNDERSIDE OF VEHICLE b. REMOVE (1) PUSH-IN RETAINING CLIP FROM LOWER REAR FLANGE OF WHEEL WELL, EACH SIDE c. RAISE LIFTGATE AND TAILGATE AND REMOVE (2) PUSH-IN RETAINING CLIPS FROM BEHIND TAILGATE AT TOP EDGE OF FASCIA. RENDEZVOUS a. REMOVE (5) PUSH-IN RET

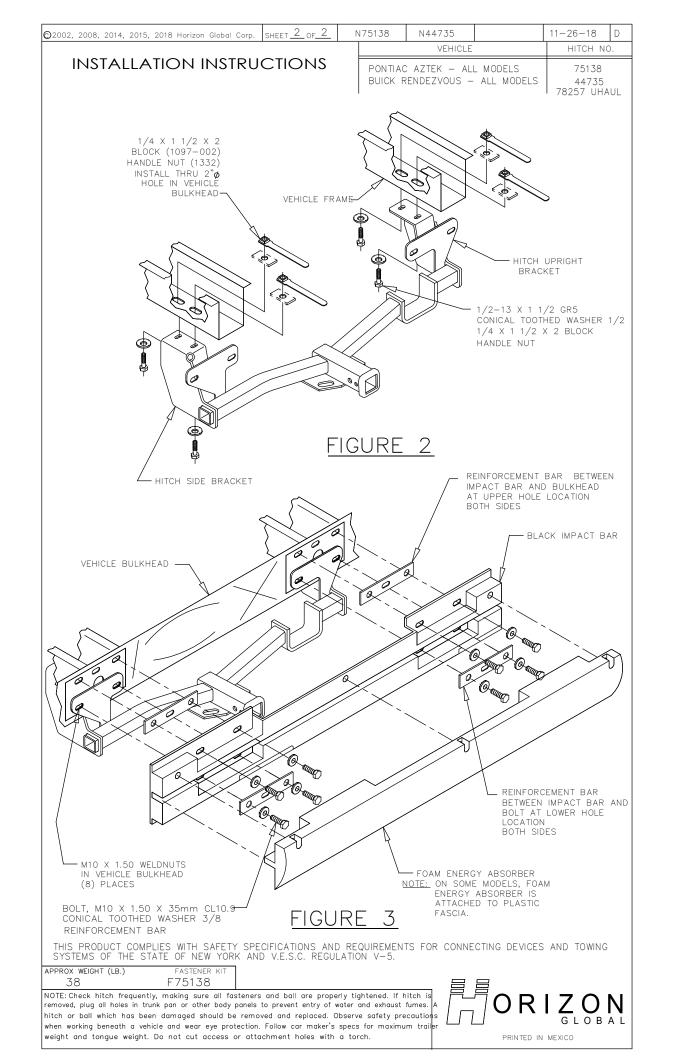
- 3. REMOVE (4) BOLTS, EACH SIDE, WHICH ATTACH BLACK IMPACT BAR TO VEHICLE, AND DISCARD.
- 4. RAISE HITCH INTO POSITION AND TEMPORARILY ATTACH TO REAR OF VEHICLE WITH M10 X 1.50 X 35mm BOLTS AND 3/8 CONICAL WASHERS PROVIDED WITH HITCH, AS SHOWN IN FIGURE 1. DO NOT TIGHTEN AT THIS TIME.

- 6. INSTALL 1/2-13 X 1 1/2" HEX HEAD BOLT AND 1/2 CONICAL TOOTHED WASHER THRU SLOTS IN HITCH SIDE BRACKETS AND INTO HANDLE NUTS, SEE FIGURE 2. DO NOT TIGHTEN AT THIS TIME.

- REMOVE M10 FASTENERS INSTALLED IN STEP 4
- 8. RAISE BLACK IMPACT BAR INTO POSITION, ALIGNING SLOTS IN IMPACT BAR WITH SLOTS IN HITCH UPRIGHT BRACKETS AND WELDNUTS IN VEHICLE BULKHEAD. ATTACH IMPACT BAR USING (4) 1/4 X 1 1/2 X 7 1 1/2 X REINFORCEMENT BARS (7111) AND (8) M10 X 1.50 X 35mm CL10.9 BOLTS AND 3/8 CONICAL WASHERS PROVIDED WITH HITCH AS SHOWN IN FIGURE 3.

- NOTE: INSTALL 1/4 X 1 1/2 X 7 1/2 REINFORCEMENT BAR (7111) BETWEEN BULKHEAD AND BLACK IMPACT BAR TO ACT AS A SPACER AT UPPER HOLE LOCATION, BOTH SIDES. INSTALL REINFORCEMENT BAR BETWEEN IMPACT BAR AND BOLT AT LOWER HOLE LOCATION, BOTH SIDES. SEE FIGURE 3 FOR PROPER ORIENTATION.

TIGHTEN M10 CL10.9 FASTENERS TO 42 LB-FT. TIGHTEN 1/2-13 GR5 FASTENERS TO 75 LB-FT.
